Manhole Inspection Summary

Manhole # S29AA_013MH

Location Address: **500 HOFFMAN ST**

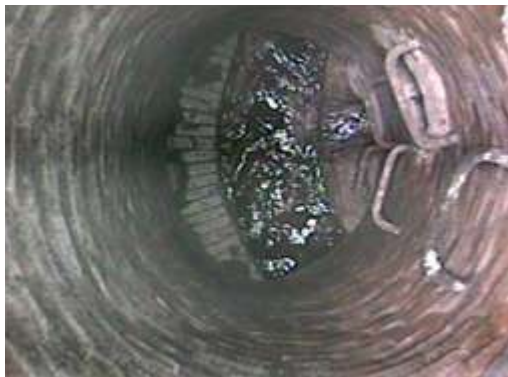
Top View

DEBRIS

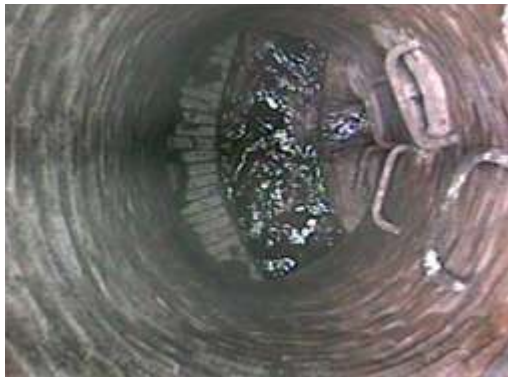
Defect 2

Condition: ☐ Sound ☐ Cracked ☐ Root Intrusion ☐ Deteriorated ☐ Leaks ☒ **Debris**

CHANNEL DEBRIS

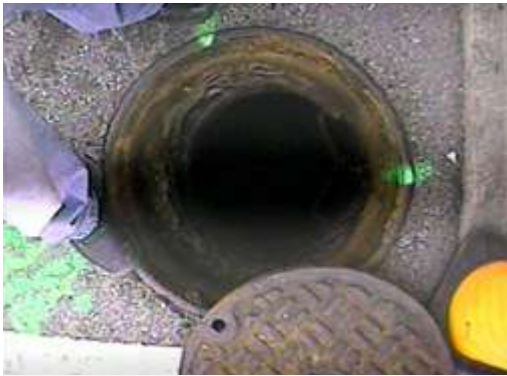
Defect 1

Offset: **3** (in.)

FRAME OFFSET

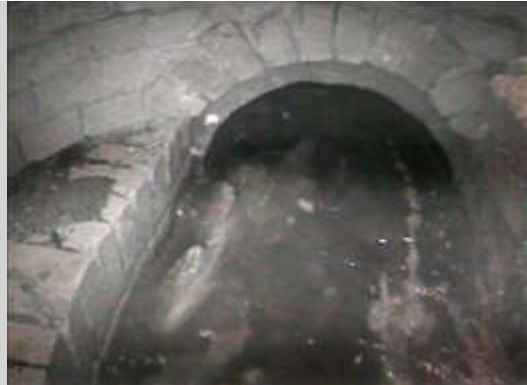
12 O'Clock Outflow

15 in. Circular Gravity Sewer
Pipe Out @ 12 O'Clock

Pipe Height: **14.4** (in.) Rod and Bar (Angled)
Pipe Material: **Clay** ☐ Pipe Lined
Invert Depth: **14.53** (ft.) Flow Characteristics: **Slow**
Deposits: ☒ None ☐ Mud ☐ Sludge ☐ Debris ☐ Grease
Silt Depth: (in.) Deposits Extent:
Infiltration: **None** Pipe Seal Cond: **Sound**

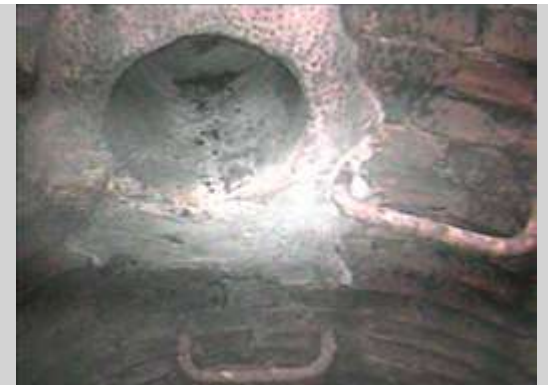
3 O'Clock Inflow

12 in. Circular Gravity Sewer
Pipe In @ 3 O'Clock

Pipe Height: **13.2** (in.) Rod and Bar (Angled)
Pipe Material: **Clay** ☐ Pipe Lined
Invert Depth: **9.14** (ft.) Flow Characteristics: **Slow**
Deposits: ☒ None ☐ Mud ☐ Sludge ☐ Debris ☐ Grease
Silt Depth: (in.) Deposits Extent:
Infiltration: **None** Pipe Seal Cond: **Sound**

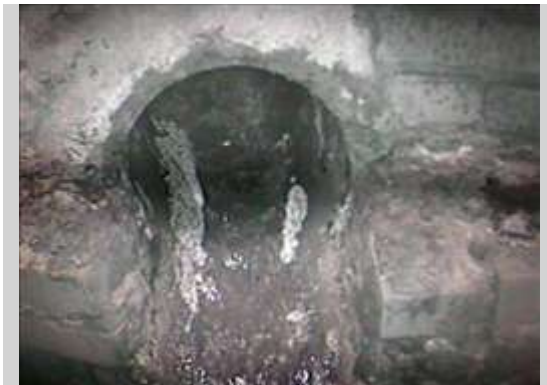
Drop In @ 3 O'Clock

Drop: **Outside Direct**
Angled: Reading: (ft.)
Inv Depth: **12.14** (ft.)
Drop Condition: **Open**

Connects To: **House connection / Service line**

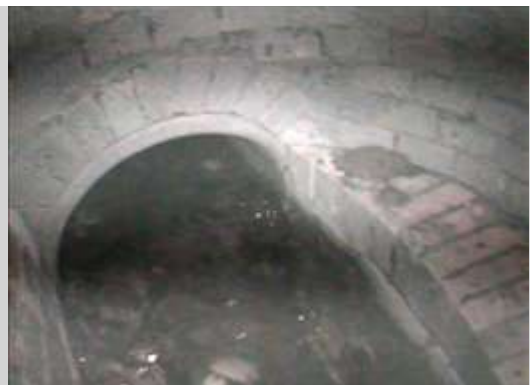
5 O'Clock Inflow

15 in. Circular Gravity Sewer
Pipe In @ 5 O'Clock

Pipe Height: **15.6** (in.) Rod and Bar (Angled)

Invert Depth: **14.00** (ft.) Flow Characteristics: **Slow**

Infiltration: **None** Pipe Seal Cond: **Sound**
